Sampling Report for August 15, 2014 WIPP Samples

Forensic Science Center
December 19, 2014

WIPP Panel 7 Sampling August 15, 2014

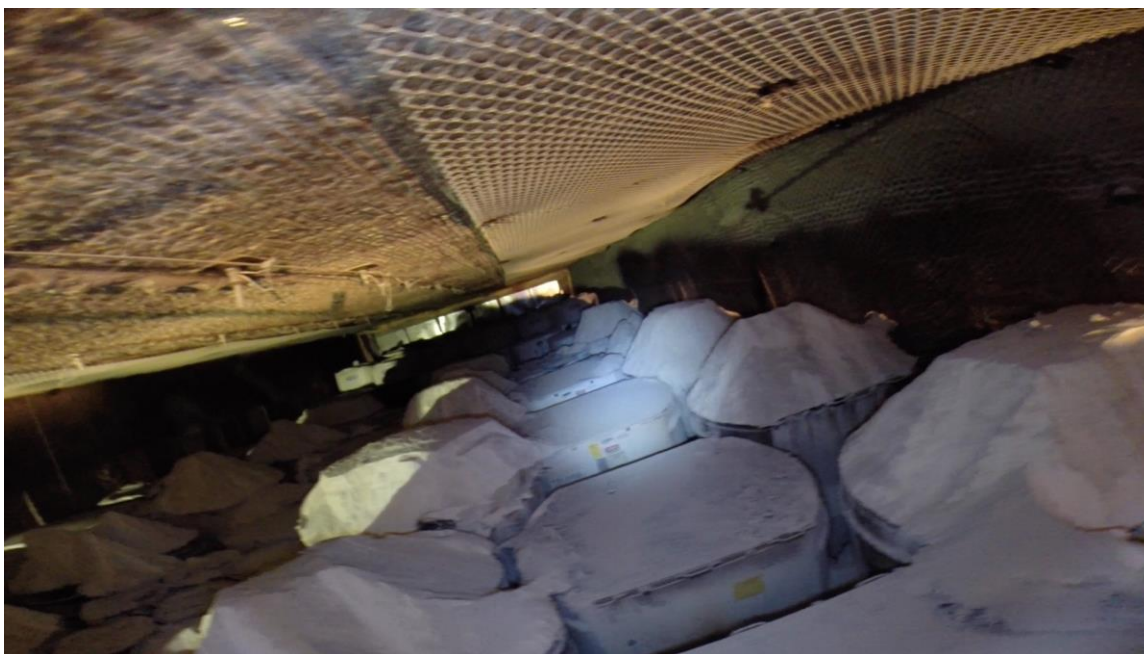
Figure 3. Photograph of current configuration of Panel 7 from the 50 ft. boom as it moves along Row 5 from the staging area.

Figure 3 shows a photograph of the general area of the breached drum, looking from the entrance of Panel 7 (and towards row 1). To understand the orientation of the picture, refer to the diagram of Figure 2. The photograph was taken looking right down Column 5. In the picture, the widespread destruction of the MgO bags is evident. As points of reference, the locations of the MgO bags that no longer have the polypropylene/cardboard containment are indicated, with tan coloring, in Figure 2. Column 5 is a column with containers that have no MgO bags on them. Drum 68660 (16-4) is on the left side of Figure 3; however, from this angle, the breach is not obvious.

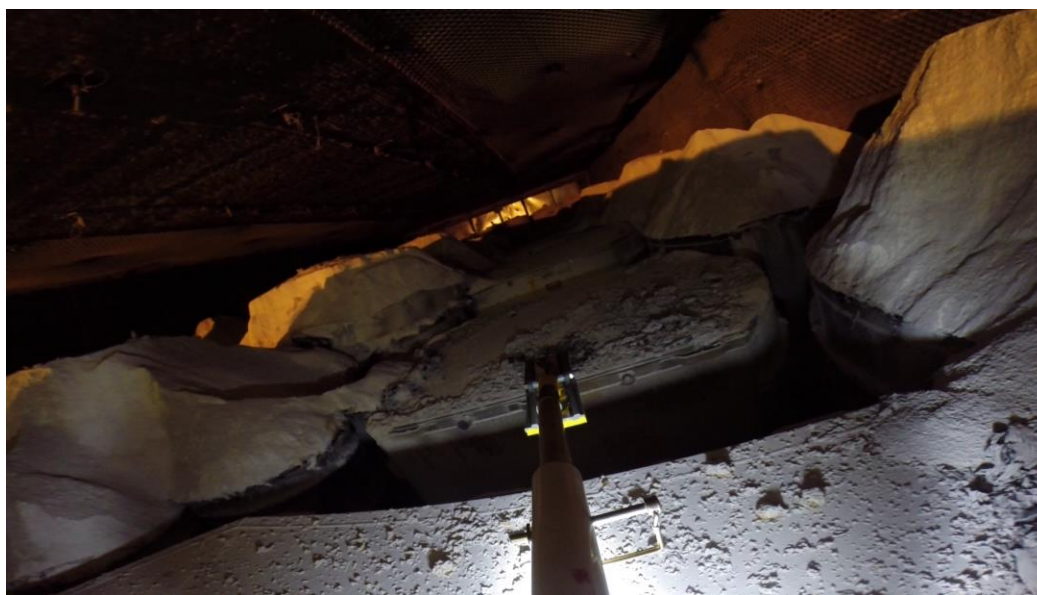
Figure 5. The Al/Ti sampling boom (taken in the May-June sampling effort).

Figure 5 shows a picture of the sampling boom used for the August 15 sampling. The sampling boom is an Al/Ti alloy beam, roughly 50-foot long. A rope and pulley system was constructed to move a camera for documentation and close-up pictures. The sampling device is located at the end of the boom. (Note, this picture is from the May-June sampling effort and has a multi-sampler on the end. For the August sampling, a redesigned bulk sampler only was used for the sampling; this is discussed below.)

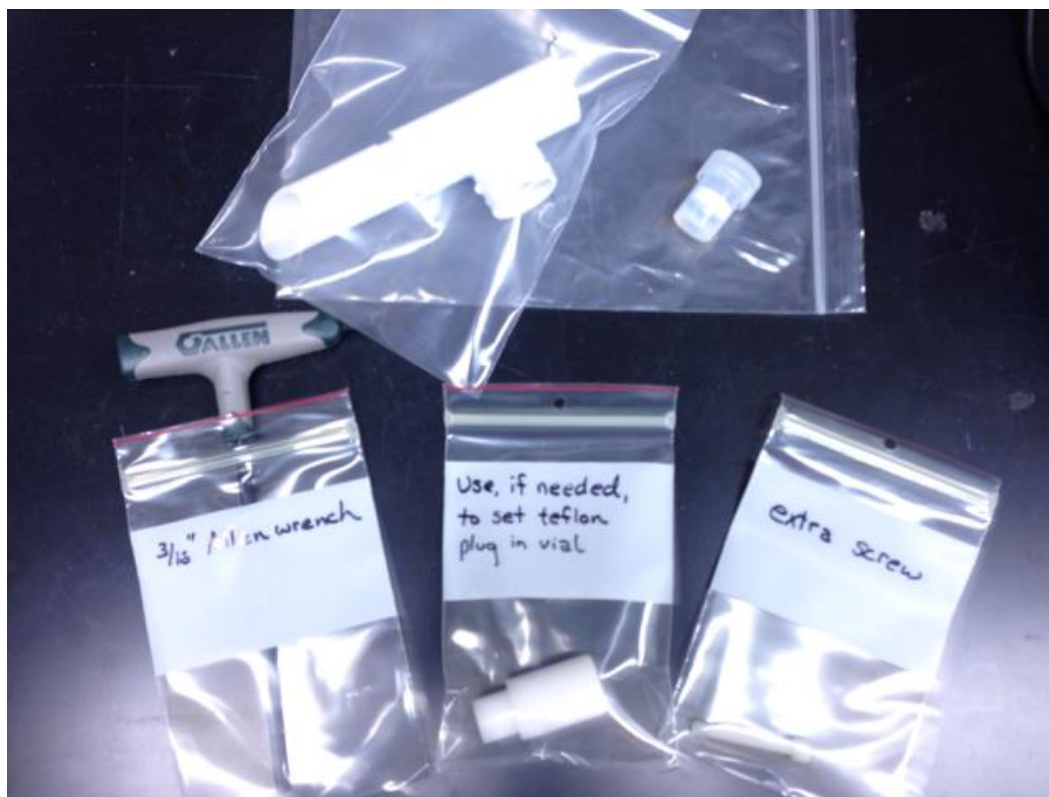
Figure 6. LLNL sampler (top bags), installation tools and plugs (bottom bags).

The newly constructed sampling device, held on the end of the sample boom, was fabricated at LLNL. Figure 6 shows the sampler and components needed for collection and containment of the samples, as well as hardware needed for manipulation of the containers. Lessons learned from the May-June sampling event indicated that the bulk MgO sampler, constructed from PVC tubing, was not sufficient to trap the MgO solid for the entire process—sampling, then retrieval to the operator.

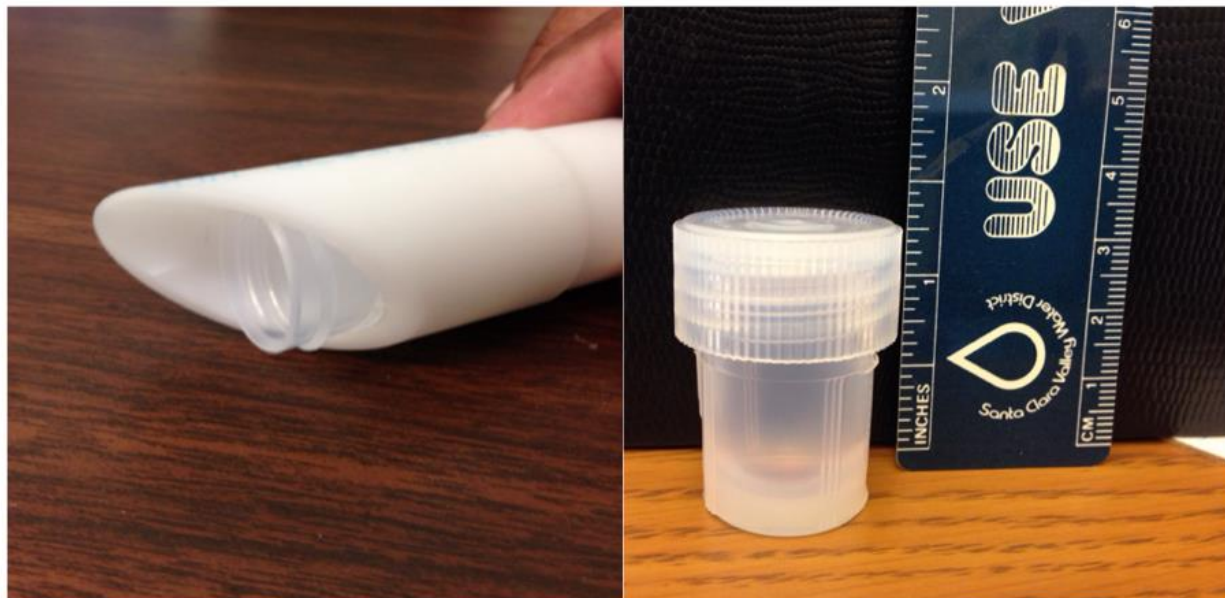
Figure 7. Close-up of sampler end and Teflon vial used in August 15, 2014 collection.

Figure 7 shows a close up of the probing end of the sampler. The sampler is constructed of Delrin®, and the sample vial is constructed of Teflon®. The diagonal cut of the tubing was machined to be very sharp to be useful for scraping difficult-to-unseat samples. The sampling probe was designed so the sample vials would fit inside. Figure 7 on the left side shows the top threads of the sample vial (without lid) in the diagonal cut of the sample probe. The sampler was attached on the end of the 50 ft. boom at a 90° angle. Although not visible in Figure 7, the Teflon® vial could be fitted with a Teflon® spacer to restrict the amount of material collected to 5 g; this was necessary to ensure that the collected mass would not exceed the safety basis mandated for sample collection. Figure 9 shows vial that has been fitted with a Teflon® spacer.

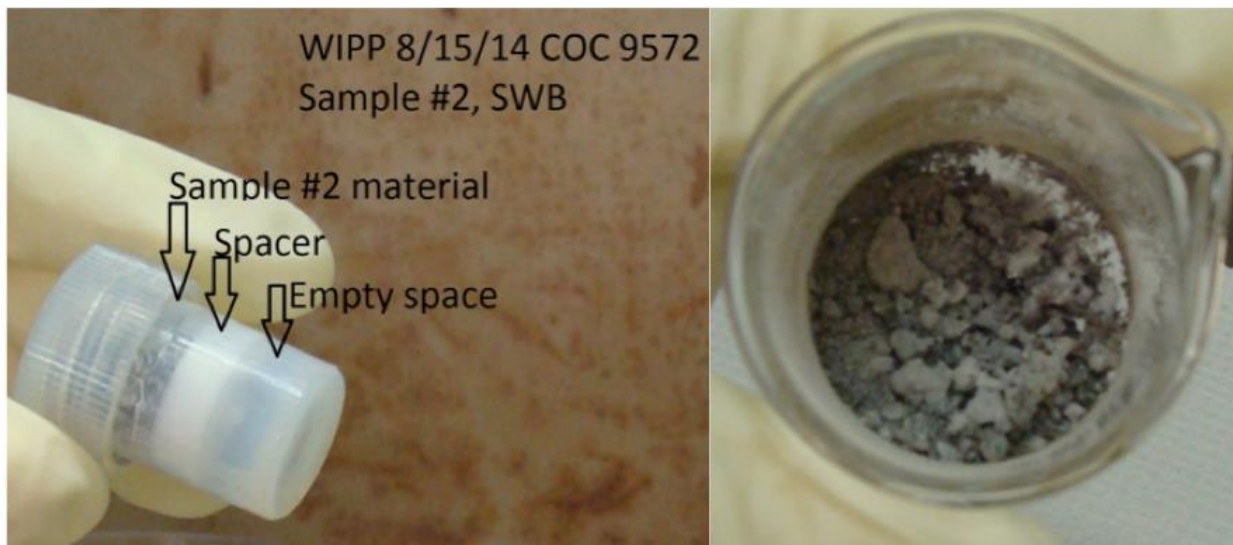
Figure 9. Sample #2 from 15-5 SWB (COC 9572), in sampling vial (left) and beaker (right).

Figure 9 shows a close-up of Sample #2 from 15-5 SWB. The left side shows the sample in the vial (note the Teflon spacer® used to restrict the volume of material collected). The right side of Figure 9 shows the color of the sample, which was significantly different than the white powder of MgO.
